Operational Inspection

Swaffham Prior Parish Council

Playarea
High Street, Swaffham Prior, Cambridgeshire, CB25
0LD

Operational Inspection - 15-January-2024 - 11:23 Inspector Martyn Lilley

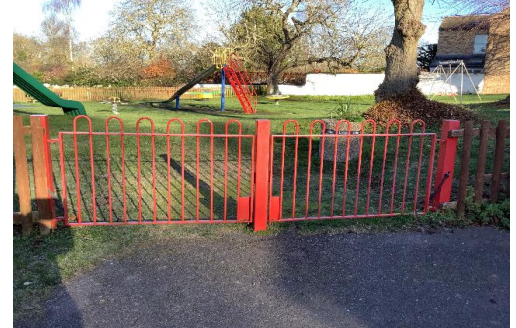
Item: Gate - Maintenance
Manufacturer: Owner/Operator
Surface Type: Tarmac
Item Quantity: 1
Equipment Compliance: N/A
Surface Area Compliance: N/A

There is no padlock on the maintenance gate - Provide a padlock to secure the gate

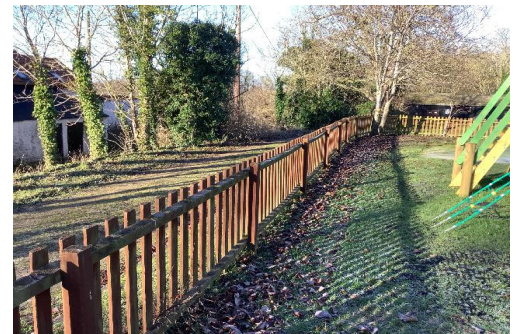
Item: Fencing - Timber
Manufacturer: Owner/Operator
Surface Type: Grass
Item Quantity: 1
Equipment Compliance: N/A
Surface Area Compliance: N/A

The item is loose in its foundations - Reinstall item to secure

There is some evidence of rot in the timber - Monitor for any further deterioration and replace as required

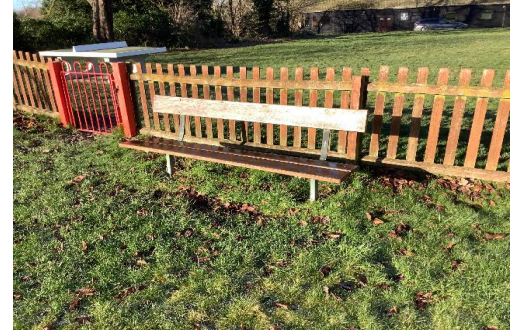
Item: Bench
Manufacturer: Owner/Operator
Surface Type: Grass
Item Quantity: 4
Equipment Compliance: N/A
Surface Area Compliance: N/A

There are projecting bolt thread(s) present - Remove excess thread length and deburr or provide cap

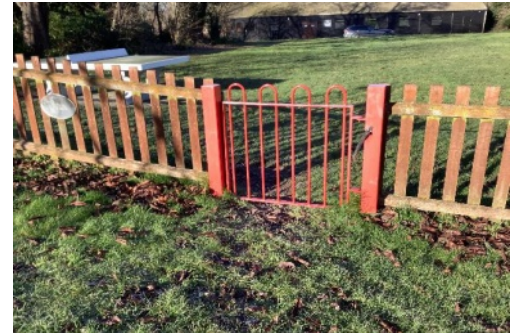
Item: Gate - Self Closing
Manufacturer: Owner/Operator
Surface Type: Grass
Item Quantity: 1
Equipment Compliance: N/A
Surface Area Compliance: N/A

This item is satisfactory - no work required -

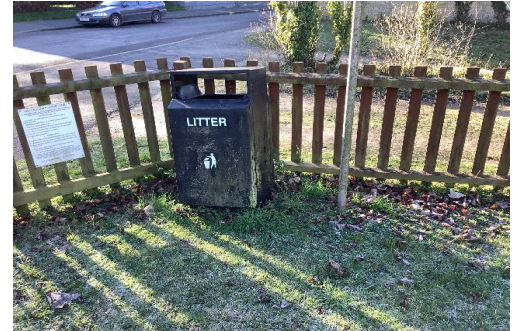
Item: Litter Bin
Manufacturer: Owner/Operator
Surface Type: Grass
Item Quantity: 1
Equipment Compliance: N/A
Surface Area Compliance: N/A

Not fixed down - Install litter bin

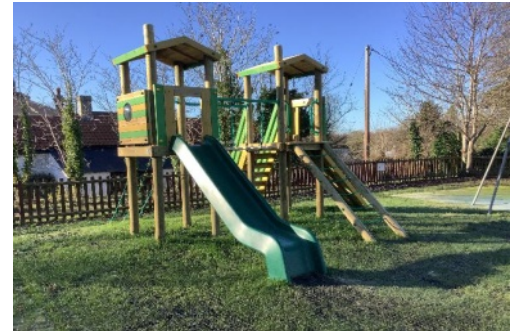
Item: Multi Play (Junior)
Manufacturer: Wicksteed Playgrounds
Surface Type: Grass Matrix Tiles
Item Quantity: 1
Equipment Compliance: N/A
Surface Area Compliance: N/A

This item is satisfactory - no work required -

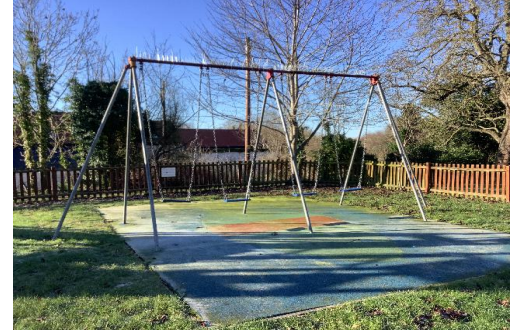
Item: 2 Bay 4 Seat (Flat)
Manufacturer: Wicksteed Playgrounds
Surface Type: Wet Pour
Item Quantity: 1
Equipment Compliance: N/A
Surface Area Compliance: N/A

The bushes are worn or missing - Replace worn or missing bushes

There are significant gaps (over 30mm) between the surface and the edging or between the joints in the surface; these are large enough for a small foot to enter - Repair surfacing

There is algae or moss growth on the surface resulting in slippery conditions - Clean and treat appropriately

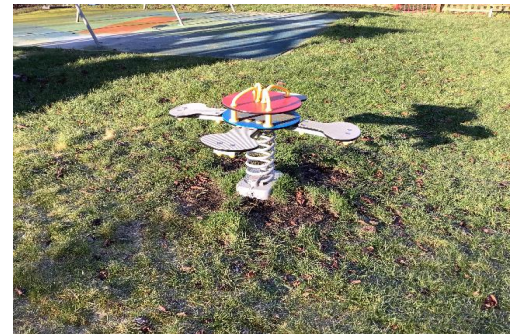
Item: Four Way Springer
Manufacturer: Ledon
Surface Type: Grass
Item Quantity: 1
Equipment Compliance: N/A
Surface Area Compliance: N/A

A number of fixing(s) have worked loose - Secure all loose fixings

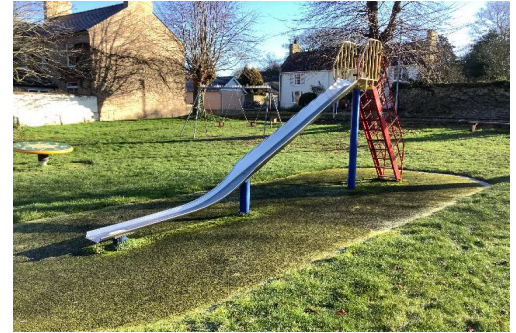
Item: Free Standing Slide
Manufacturer: Wicksteed Playgrounds
Surface Type: Wet Pour
Item Quantity: 1
Equipment Compliance: N/A
Surface Area Compliance: N/A

There is algae or moss growth on the surface resulting in slippery conditions - Clean and treat appropriately

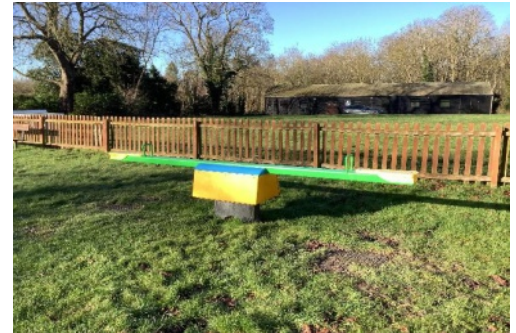
Item: See Saw
Manufacturer: Wicksteed Playgrounds
Surface Type: Grass Matrix Tiles
Item Quantity: 1
Equipment Compliance: N/A
Surface Area Compliance: N/A

This item is satisfactory - no work required -

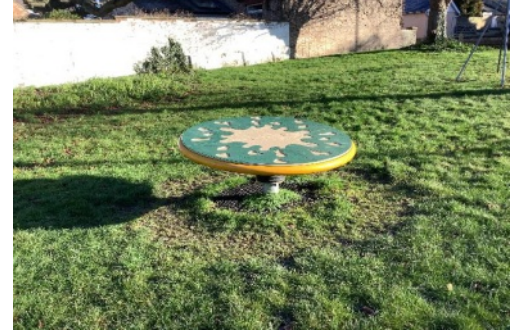
Item: Giant Revolving Disc
Manufacturer: Wicksteed Playgrounds
Surface Type: Grass Matrix Tiles
Item Quantity: 1
Equipment Compliance: N/A
Surface Area Compliance: N/A

This item is satisfactory - no work required -

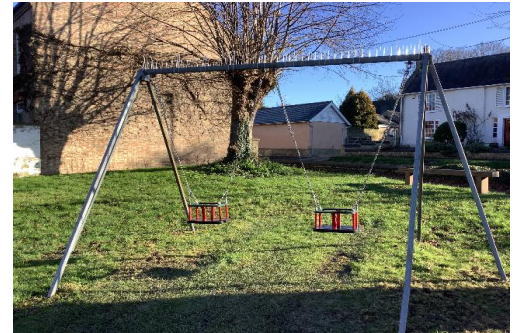
Item: 1 Bay 2 Seat (Cradle)
Manufacturer: Owner/Operator
Surface Type: Grass Matrix Tiles
Item Quantity: 1
Equipment Compliance: N/A
Surface Area Compliance: N/A

The bushes are worn or missing - Replace worn or missing bushes

Entrapment present in chains - Remove entrapments

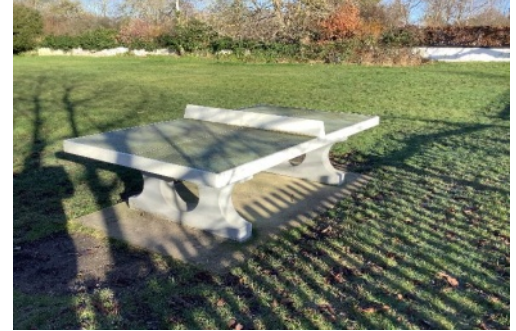
Item: Table Tennis
Manufacturer: Owner/Operator
Surface Type: Concrete
Item Quantity: 1
Equipment Compliance: N/A
Surface Area Compliance: N/A

This item is satisfactory - no work required -

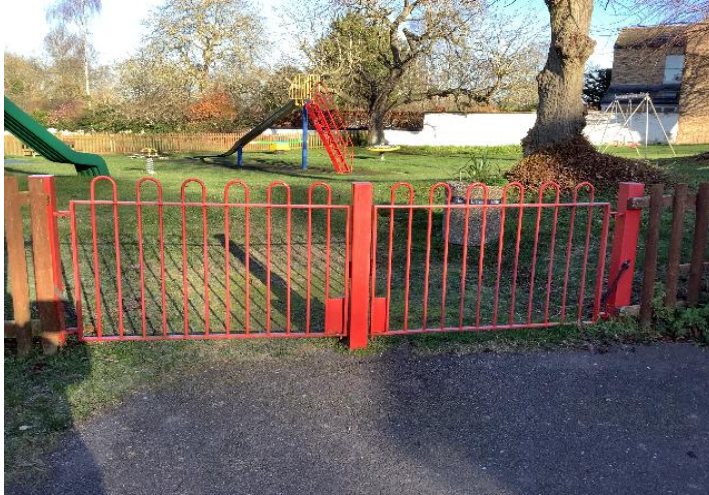
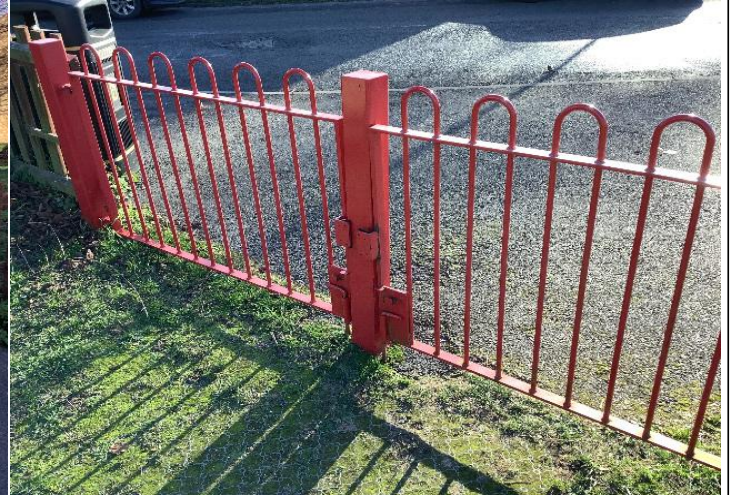
Item: Gates - Gate - Maintenance
Manufacturer: Owner/Operator

Finding: There is no padlock on the maintenance gate

Action: Provide a padlock to secure the gate

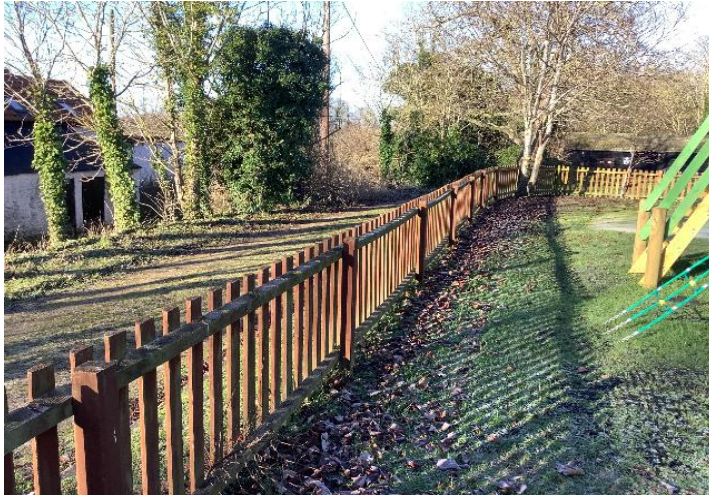
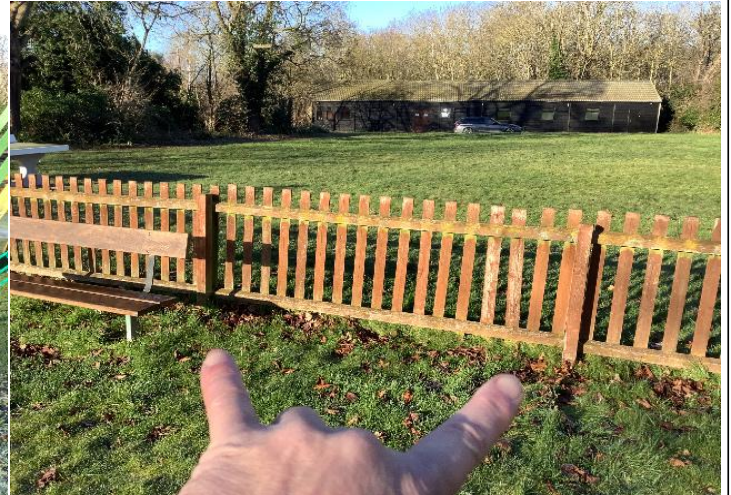
Item: Fences - Fencing - Timber
Manufacturer: Owner/Operator

Finding: The item is loose in its foundations

Action: Reinstall item to secure

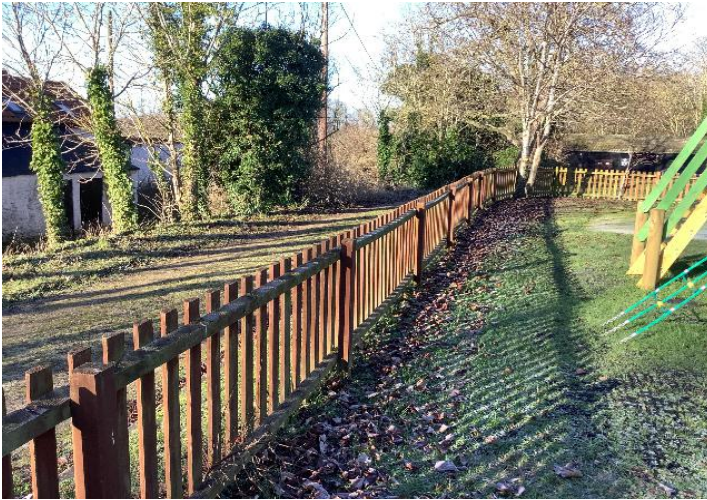
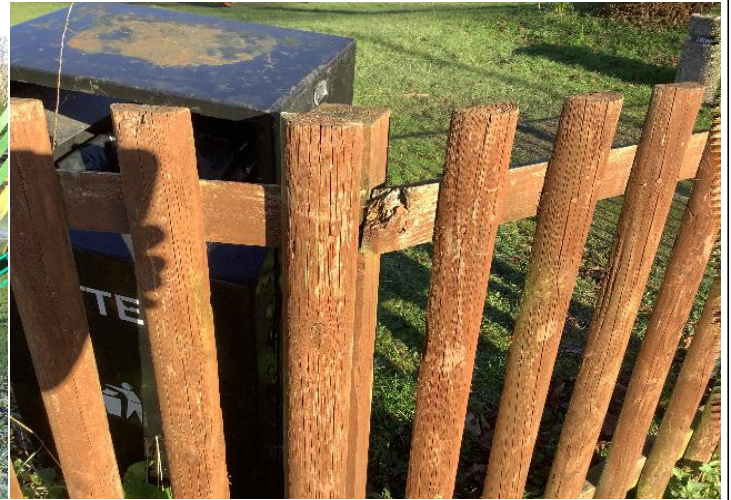
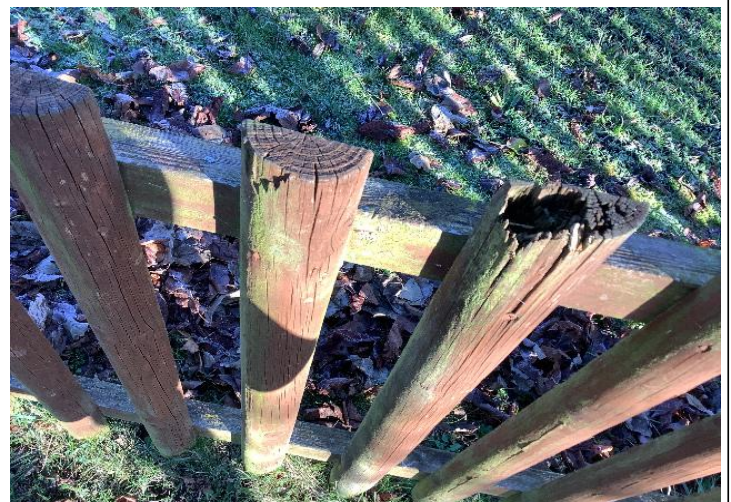
Item: Fences - Fencing - Timber
Manufacturer: Owner/Operator

Finding: There is some evidence of rot in the timber

Action: Monitor for any further deterioration and replace as required

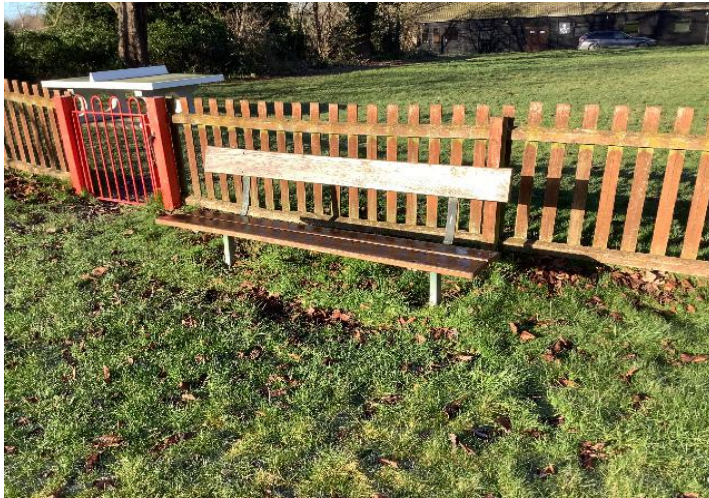
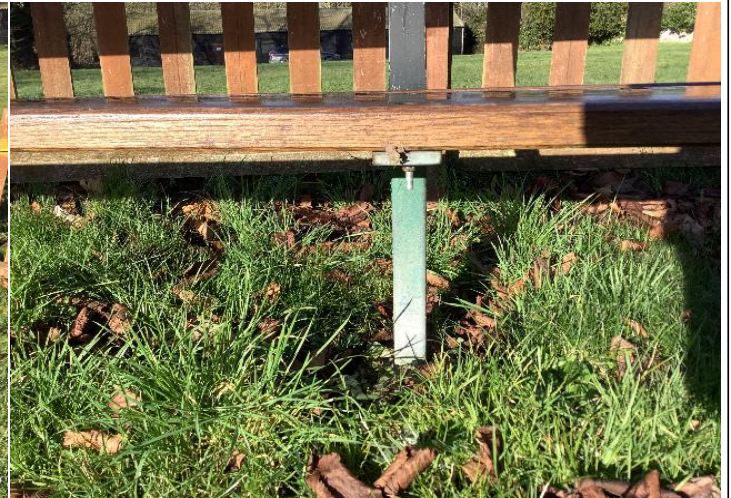
Item: Ancillary Items - Bench
Manufacturer: Owner/Operator

Finding: There are projecting bolt thread(s) present

Action: Remove excess thread length and deburr or provide cap

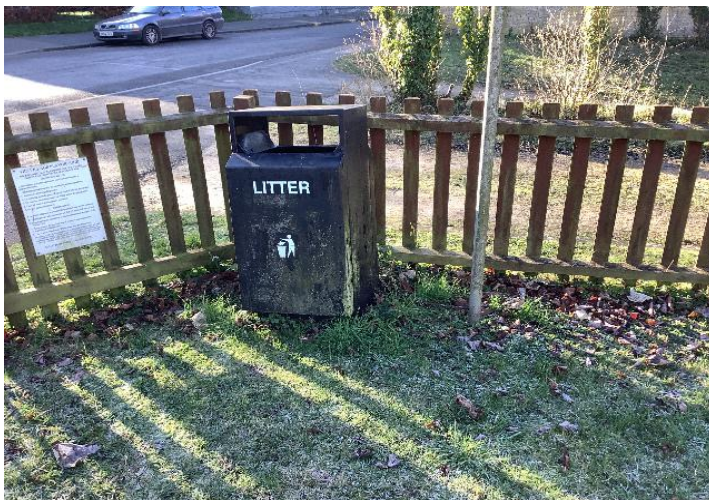
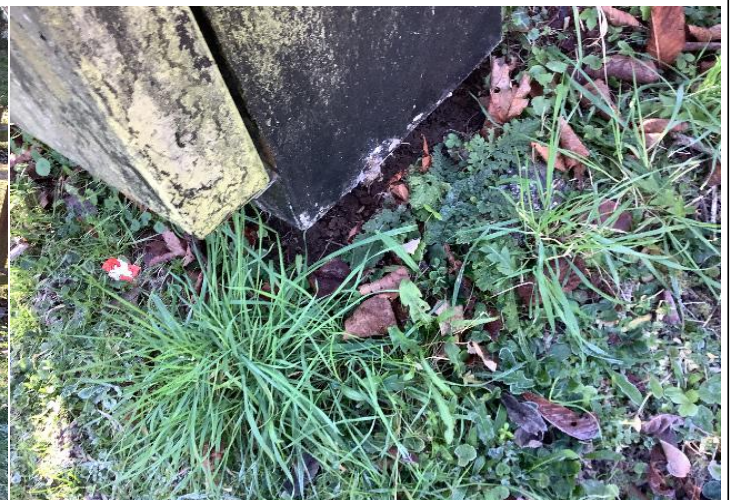
Item: Ancillary Items - Litter Bin
Manufacturer: Owner/Operator

Finding: Not fixed down

Action: Install litter bin

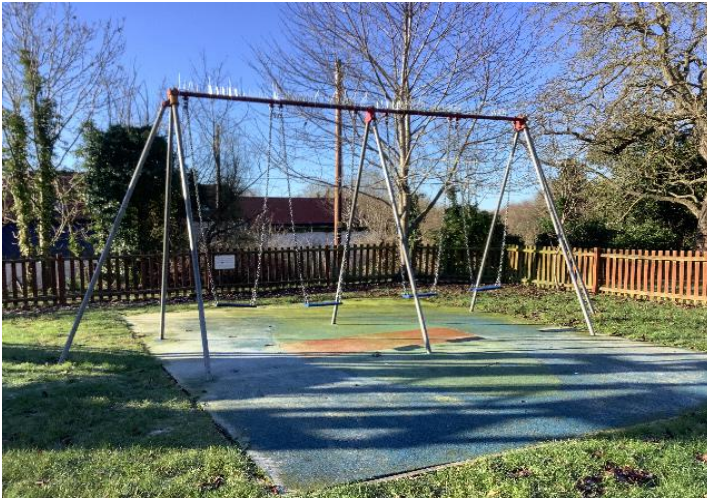
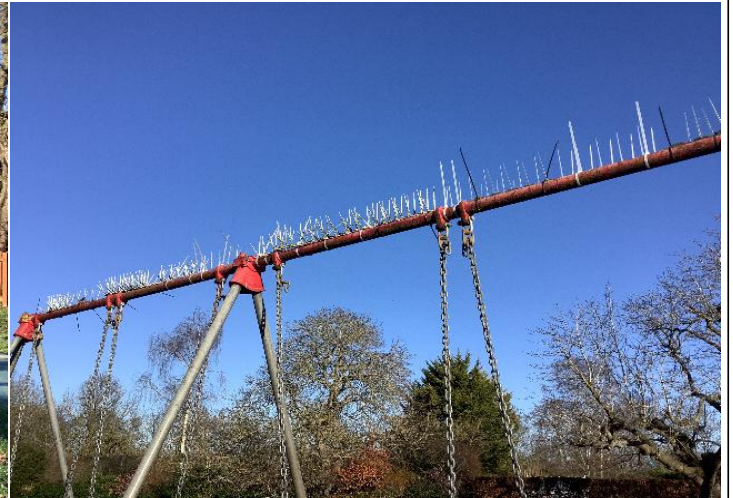
Item: Swings - 2 Bay 4 Seat (Flat)
Manufacturer: Wicksteed Playgrounds

Finding: The bushes are worn or missing

Action: Replace worn or missing bushes

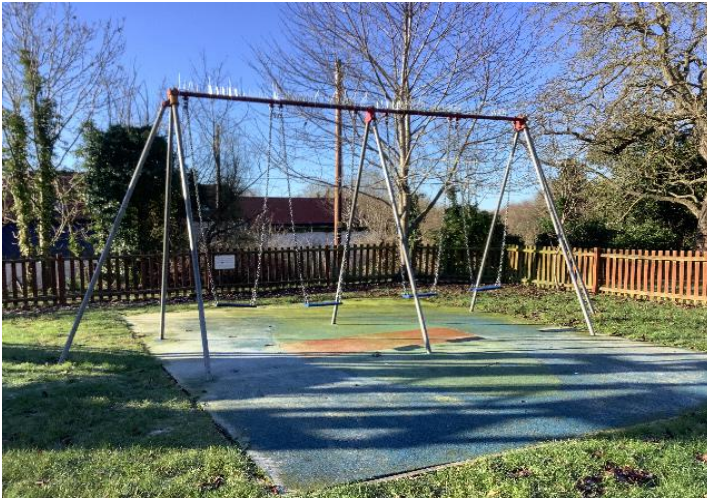
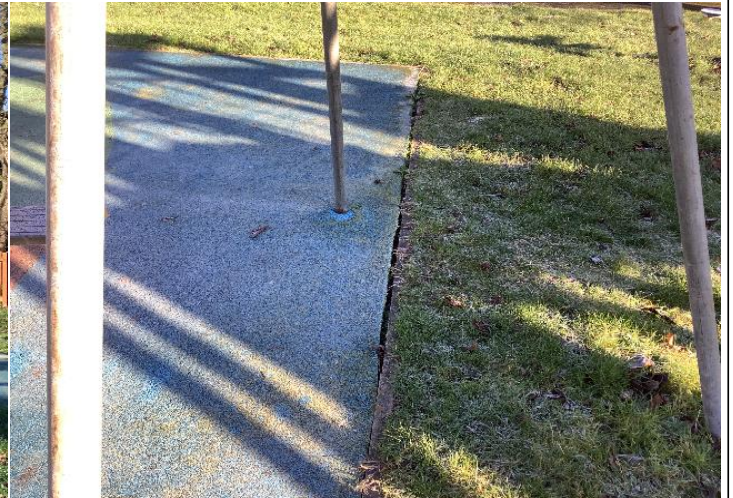
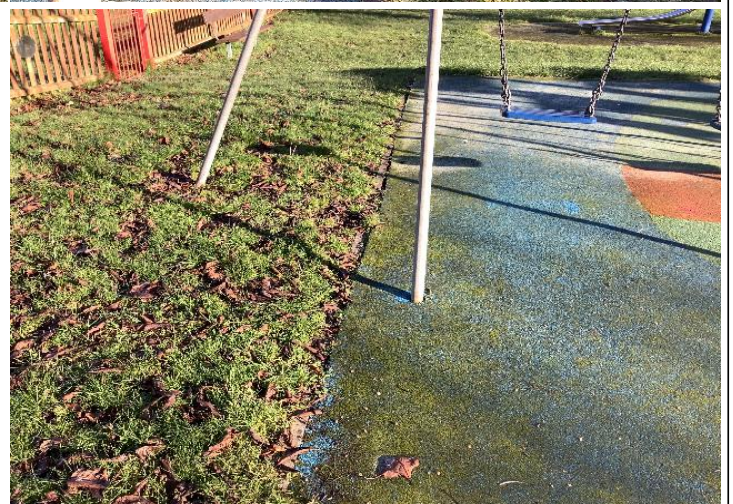
Item: Swings - 2 Bay 4 Seat (Flat)
Manufacturer: Wicksteed Playgrounds

Finding: There are significant gaps (over 30mm) between the surface and the edging or between the joints in the surface; these are large enough for a small foot to enter

Action: Repair surfacing

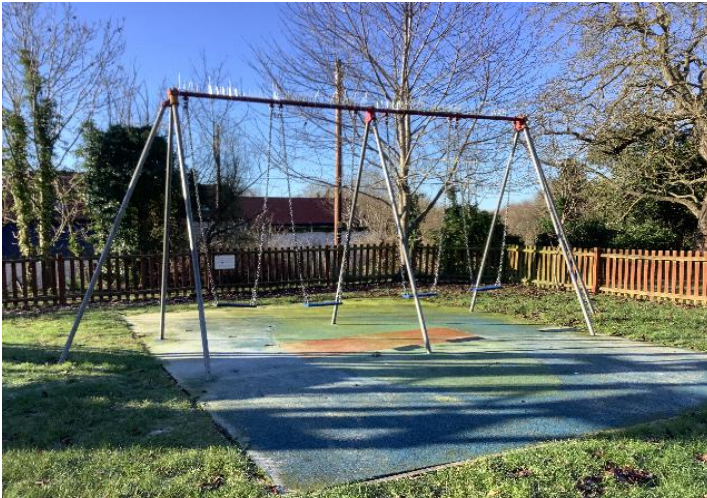
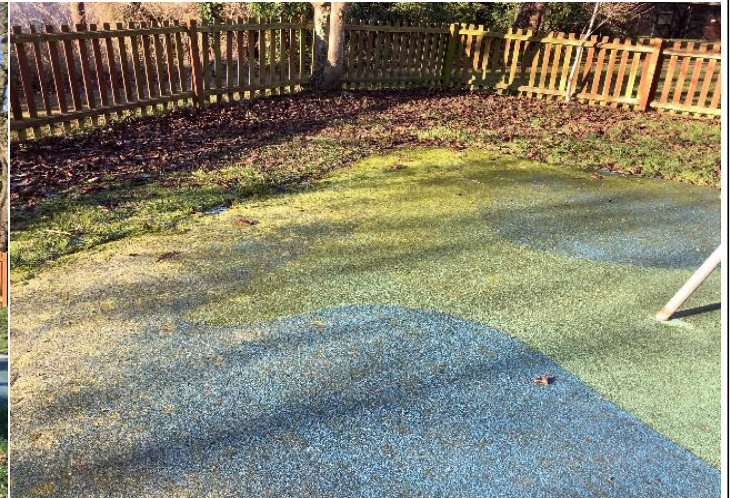
Item: Swings - 2 Bay 4 Seat (Flat)
Manufacturer: Wicksteed Playgrounds

Finding: There is algae or moss growth on the surface resulting in slippery conditions

Action: Clean and treat appropriately

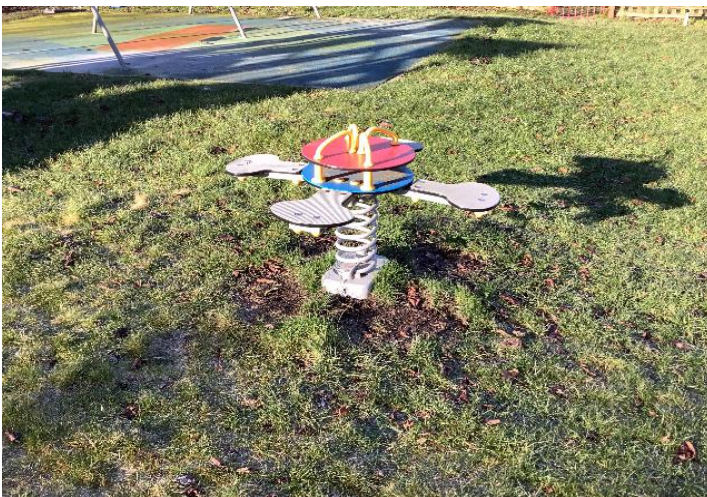
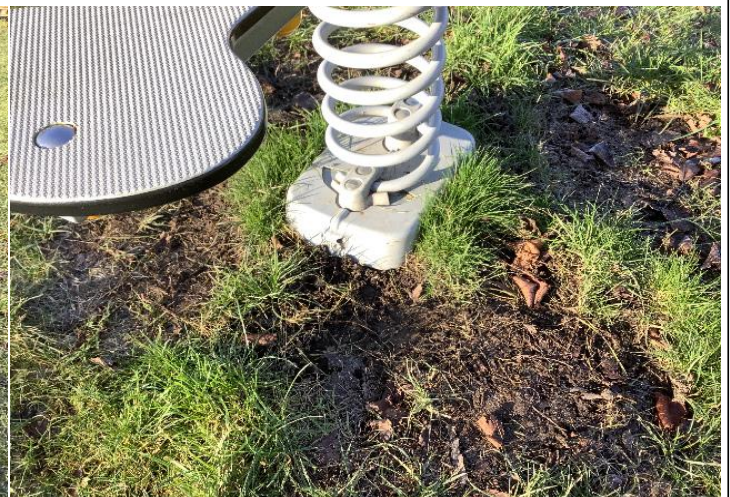
Item: Rocking Equipment - Four Way Springer
Manufacturer: Ledon

Finding: A number of fixing(s) have worked loose

Action: Secure all loose fixings

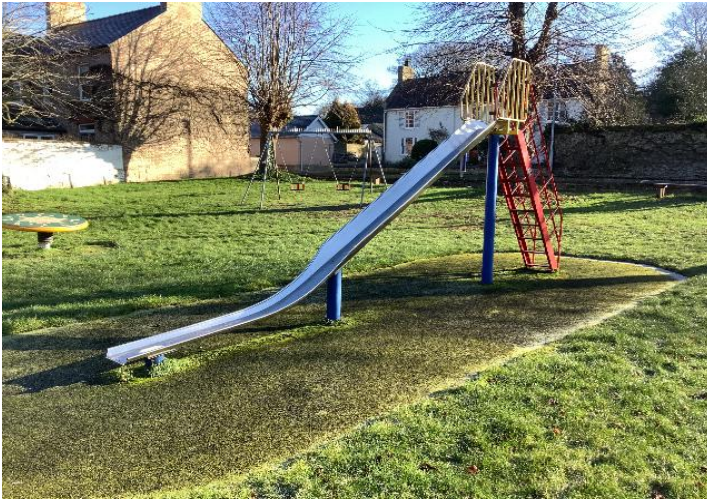
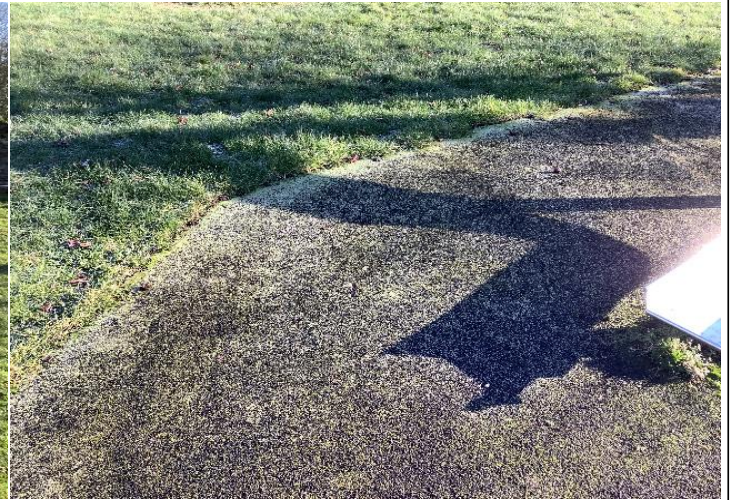
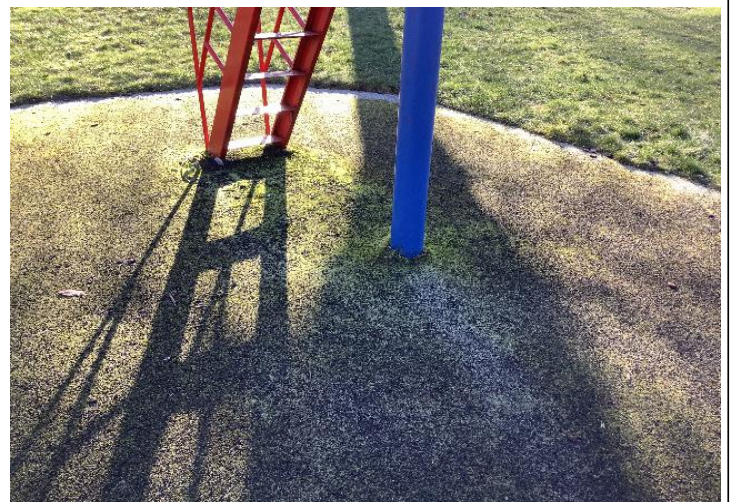
Item: Other - Free Standing Slide
Manufacturer: Wicksteed Playgrounds

Finding: There is algae or moss growth on the surface resulting in slippery conditions

Action: Clean and treat appropriately

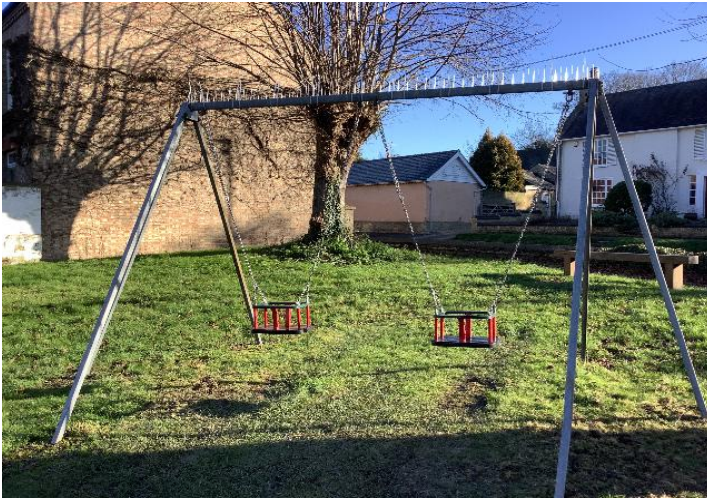
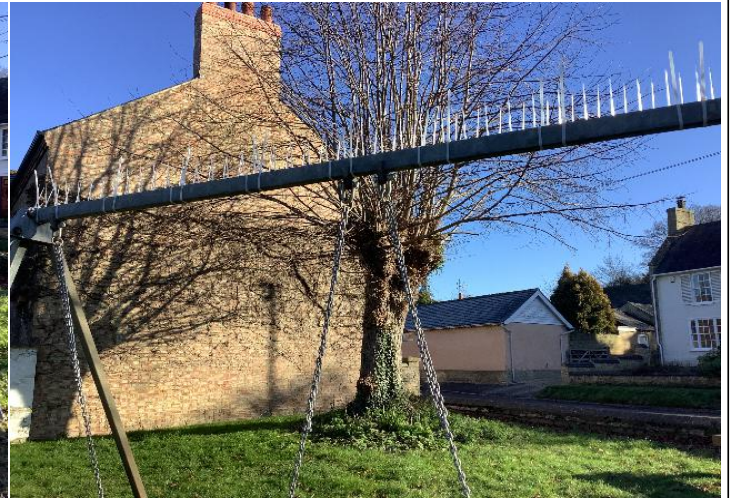
Item: Swings - 1 Bay 2 Seat (Cradle)
Manufacturer: Owner/Operator

Finding: The bushes are worn or missing

Action: Replace worn or missing bushes

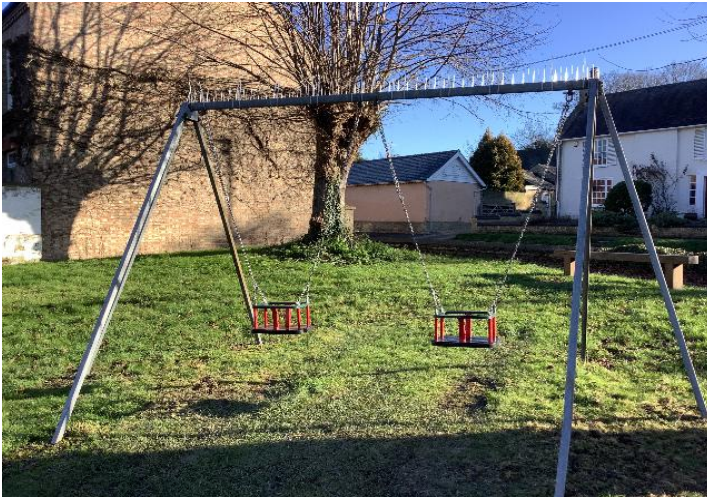
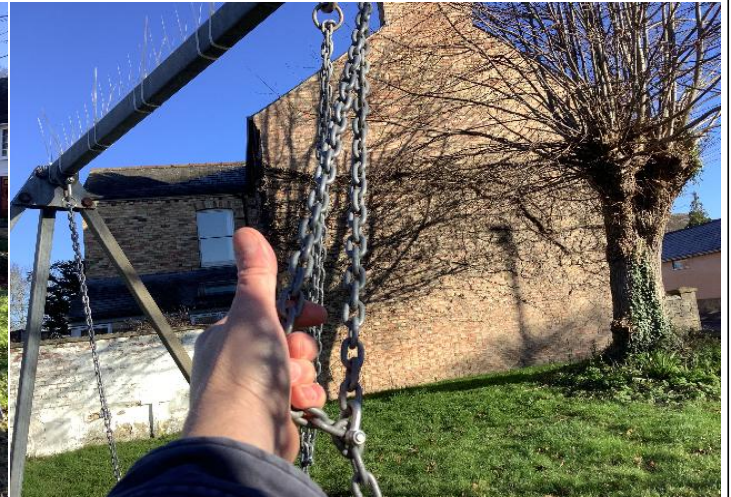
Item: Swings - 1 Bay 2 Seat (Cradle)
Manufacturer: Owner/Operator

Finding: Entrapment present in chains

Action: Remove entrapments
